ADDENDUM TWO QUESTIONS and ANSWERS

RE: Addendum for Request for Proposal Number 6905 Z1 to be opened **July 15, 2024**
~~July 11, 2024~~ at 2:00 P.M. Central Time

KUON
Ithaca, NE
2023

INSPECTION REPORT

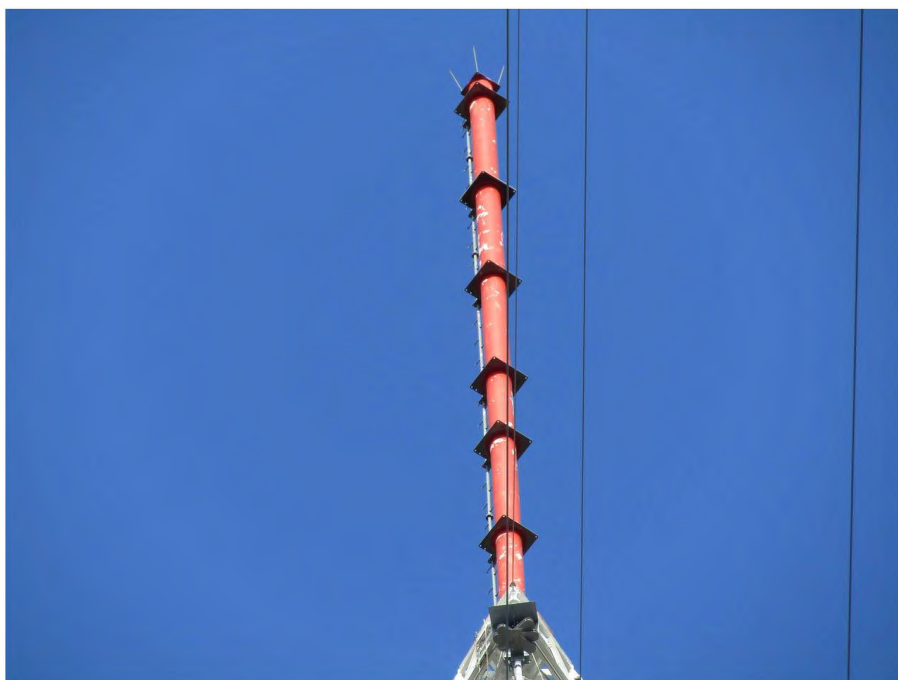
1

Profile view of main antenna. Photo also shows faded and missing paint.

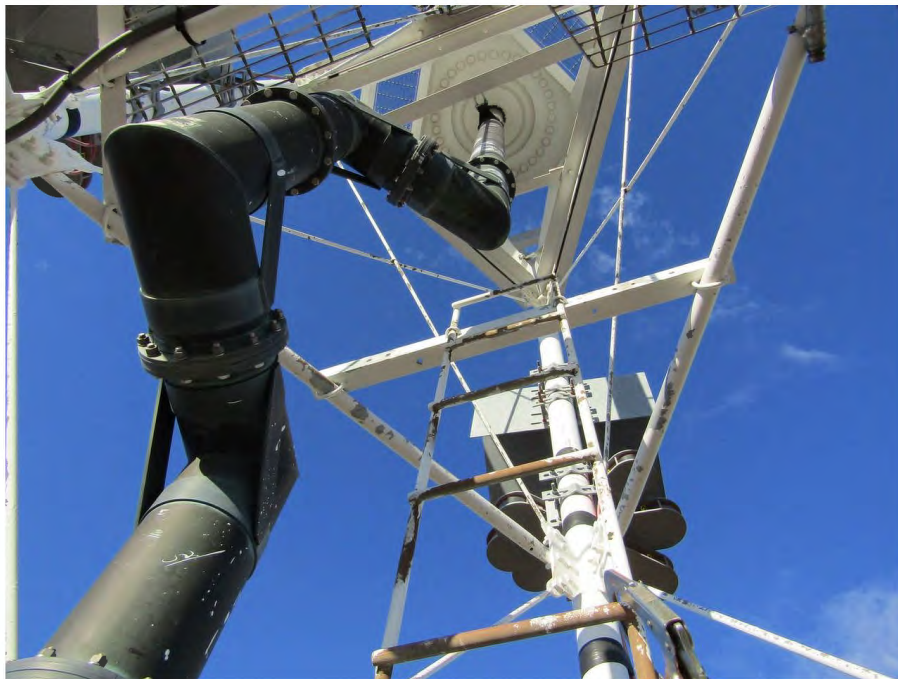
4

There are areas of surface rust on the ladder where the galvanizing appears to be worn off. We recommend that the rusting areas be treated.

Transmission line elbow complex below the antenna input. Photo also shows some surface rust on the ladder.

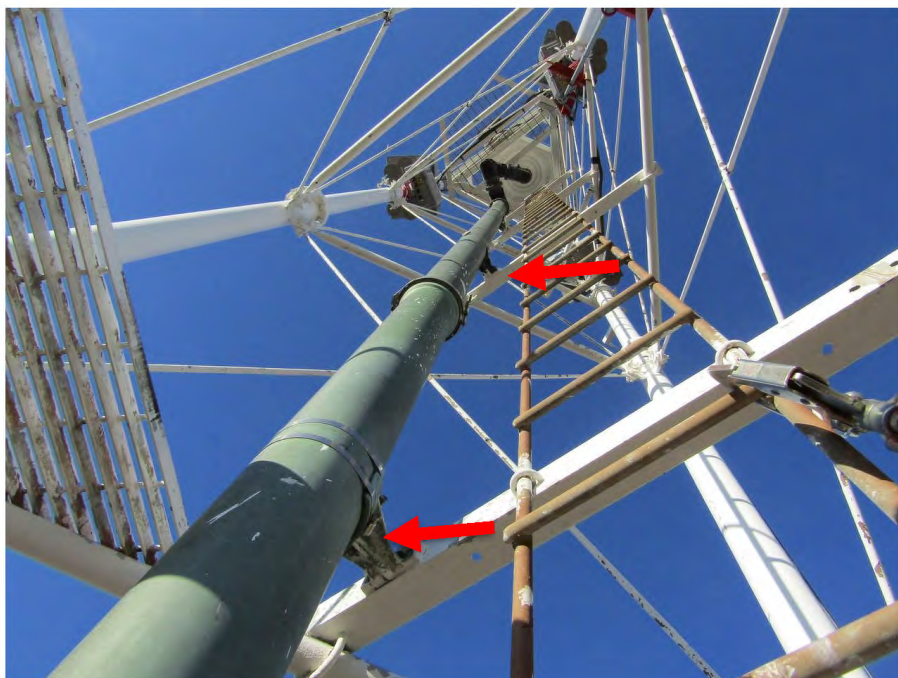
5

Fixed hangers below the top elbow complex. Photo also shows some surface rust on the ladder.

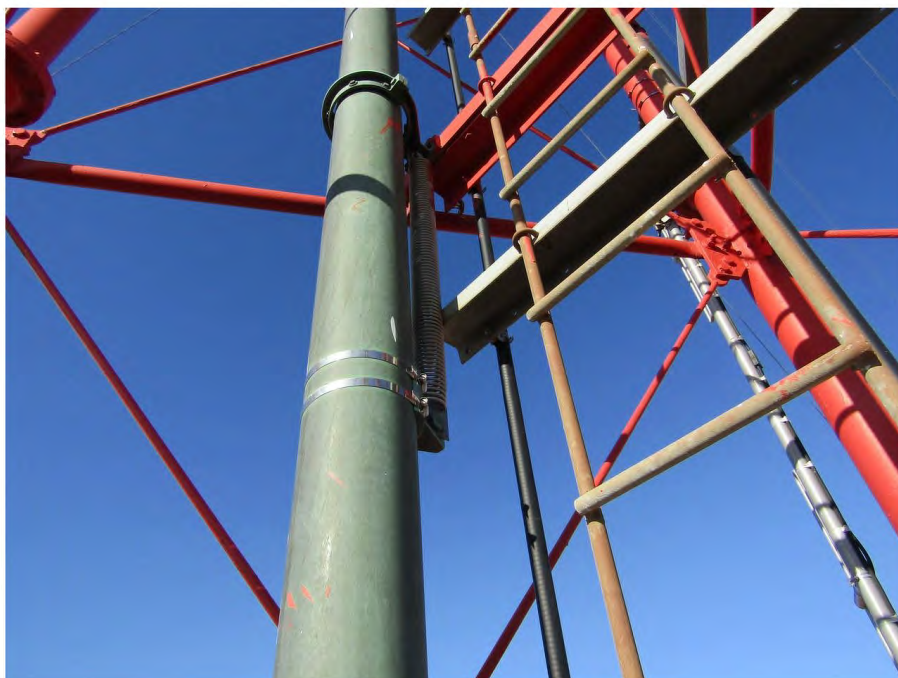
7

Typical spring hanger. Photo also shows surface rust on the ladder.

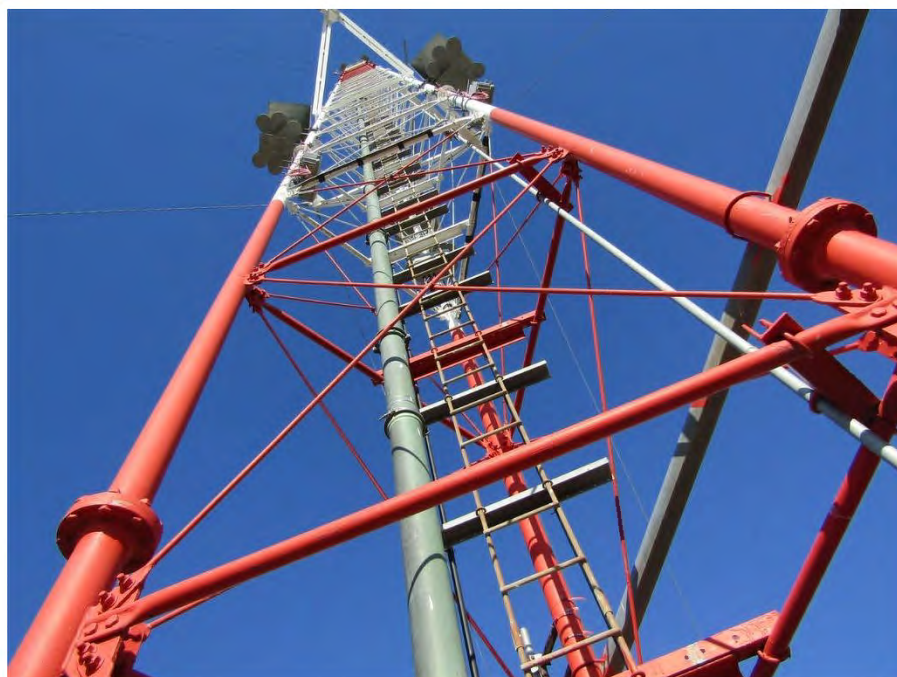
13

There are multiple brackets secured to the back side of the ladder at several elevations throughout the tower. The brackets are impeding the climbing area and some look to be preventing the climber from putting his foot directly on the ladder rung, and more on the C-channel that is bolted to it. This represents a potential climbing hazard and is a safety concern. We recommend that two runs of rigid conduit be installed to support the coax lines, and the brackets be removed from the ladder. ****Priority**

Typical bracing configuration. Photo also shows C-channel brackets secured to the back side of the ladder.

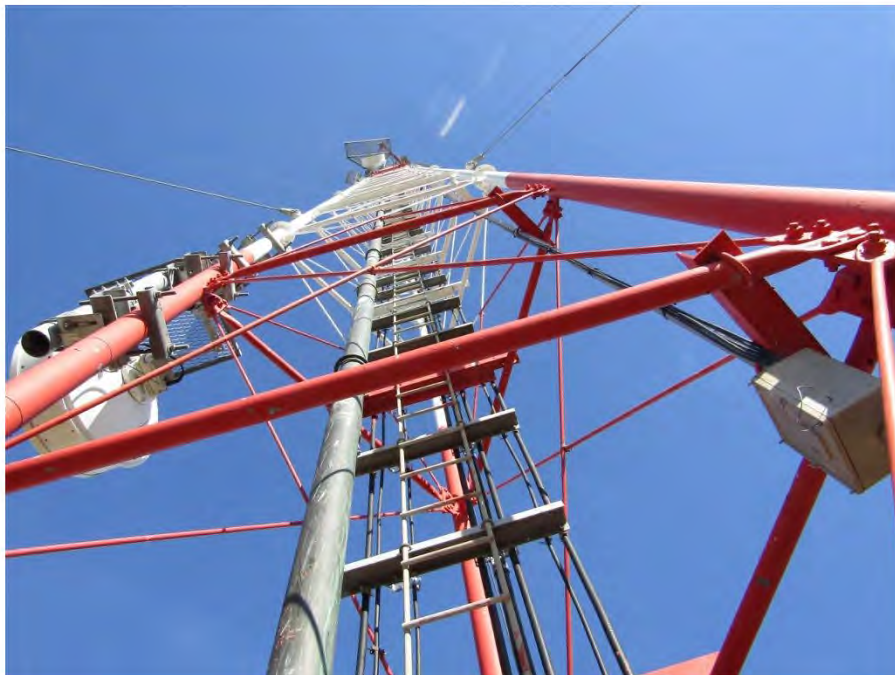
14

The ladder does not have a safety climb cable system. We recommend that one be installed to comply with the ANSI TIA 222-G 12.3 code. ****Priority**

The climbing ladder without a safety climb cable system. Photo also shows C-channel brackets secured to the back side of the ladder.

1. Install new customer supplied safety cable on main ladder in tower shaft and at top transition ladder.
2. Replace 4 customer supplied diagonal members and hardware, 1 in S.10 B.2, S.15 B.1, S.17 B.3 and one in S.30 B.3.

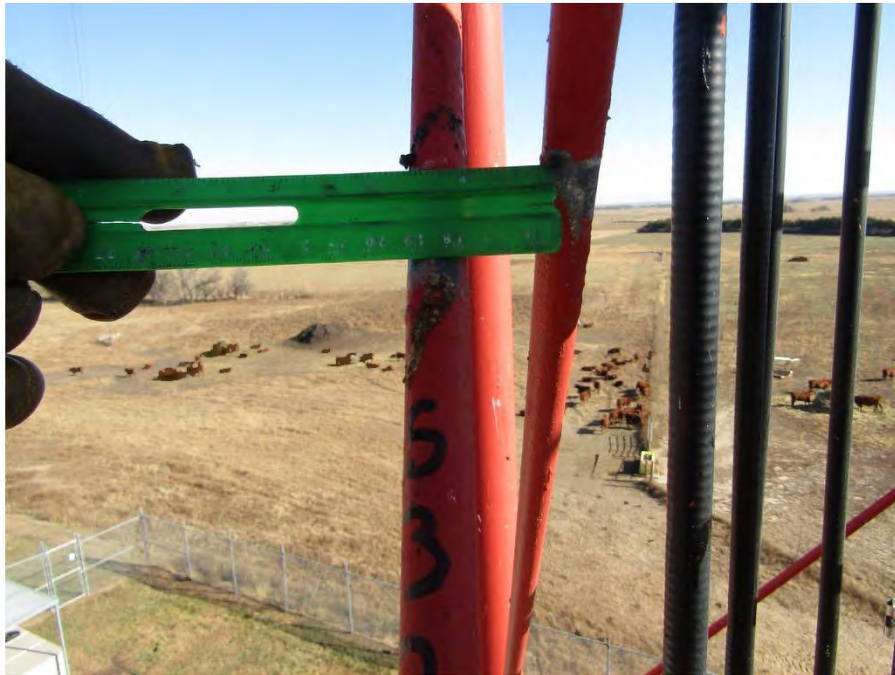
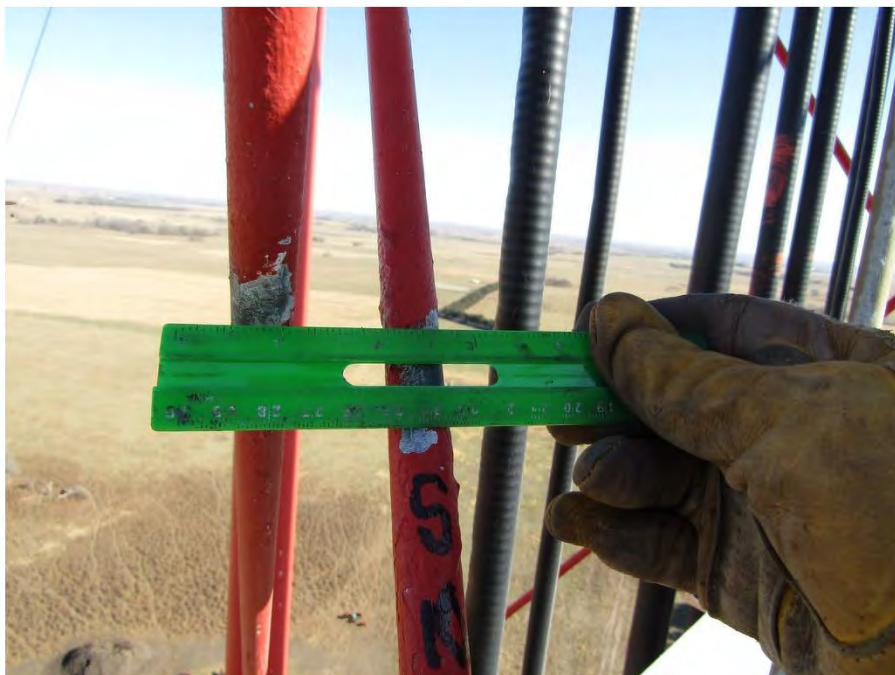
The banding that secures diagonal members at their intersections is loose or missing in multiple sections throughout the tower. The banding is stretching over time. These conditions can cause wear and loss of steel where the diagonal members rub and hit each other at the intersections. We recommend that the banding be removed from all diagonals throughout the tower and replaced with U-bolts and backing plates.

Typical missing banding at the intersection of diagonals.

7. Rust treat spots in tower.
8. Remove wrap lock at all diagonal intersections and install customer provided U bolt assembly with backing plate and hardware. U-bolts and backing plates are customer supplied – approx. qty 400.

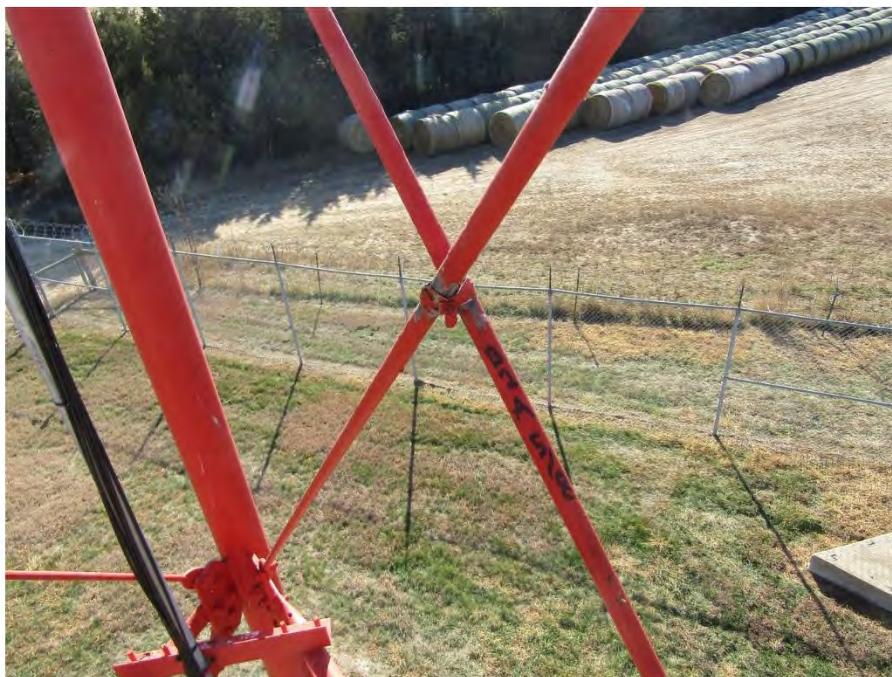
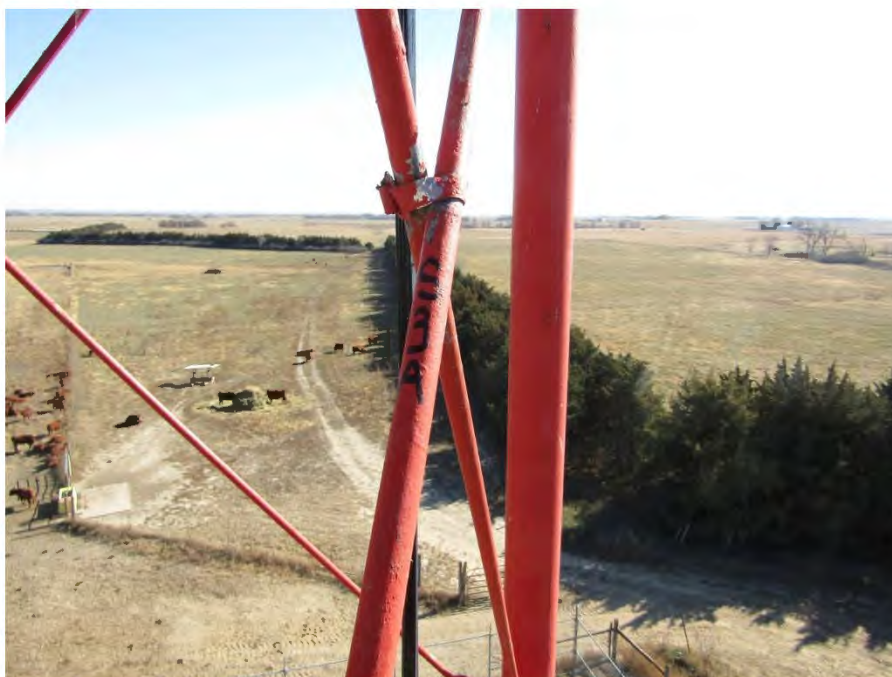
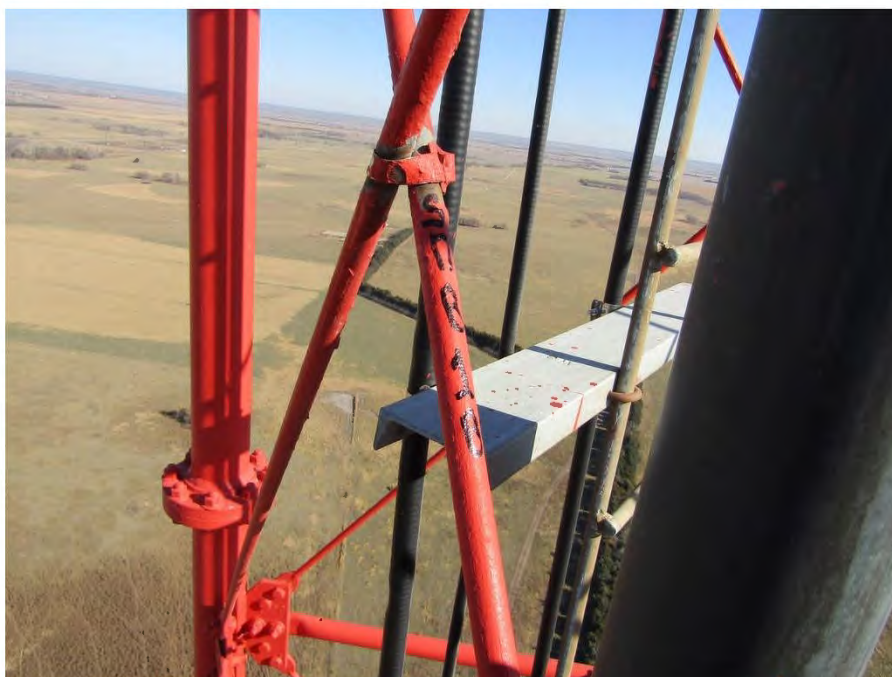
Typical loose banding at the intersection of diagonals.

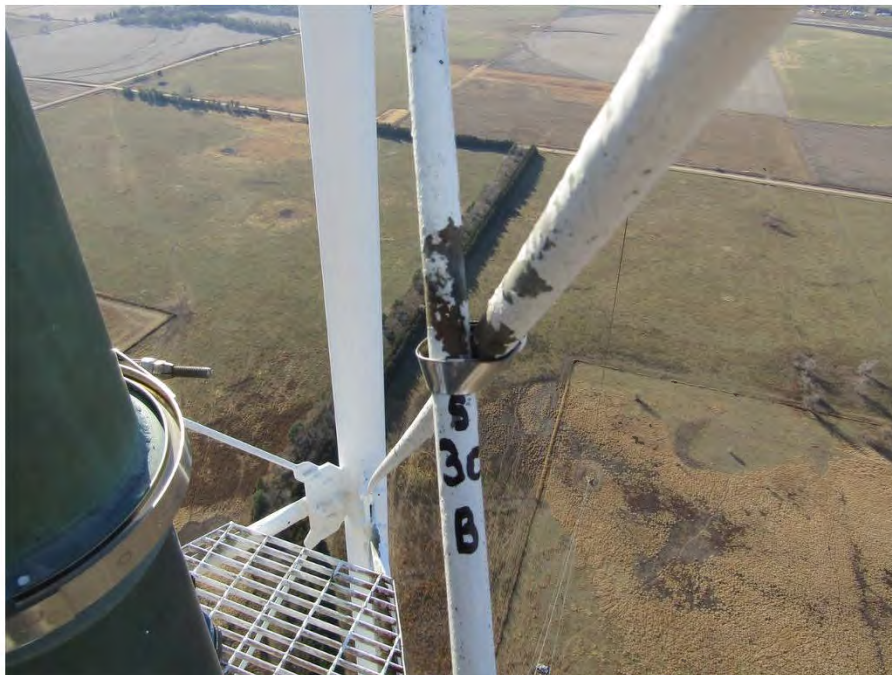
20

There is surface rust at the intersection of some diagonal members that have loose or missing banding. We recommend that all rusting areas be treated and coated with a high zinc content primer when the bandings are replaced with U-bolts and backing plates.

Typical loose banding at the intersection of diagonals. Photo also shows rust at the intersection of the diagonal members.

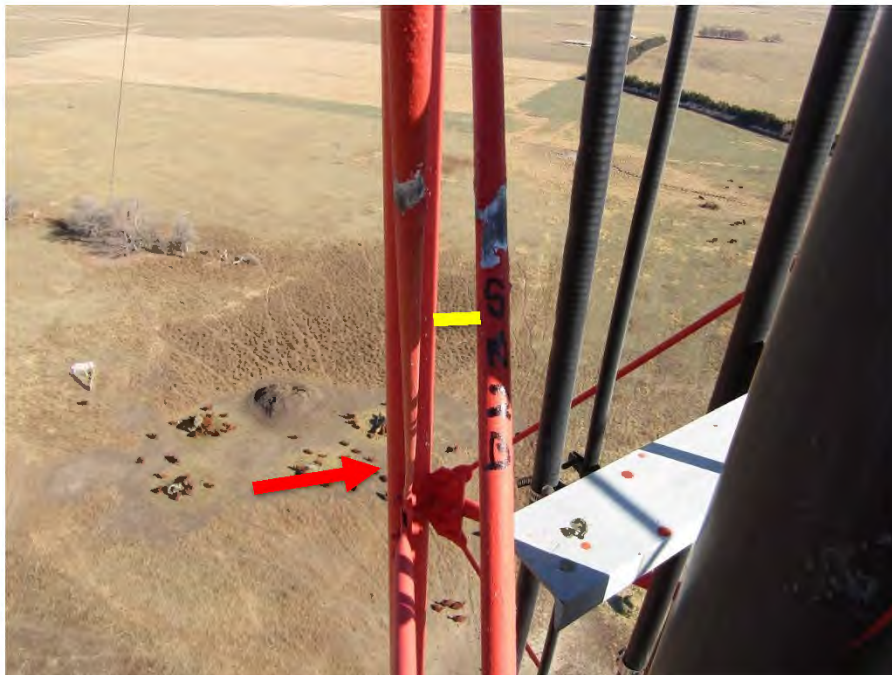
22

One diagonal member in Section #10, Bay #2, on Face B is bent. We recommend that this member be replaced. ****Priority**

Bent diagonal member in Section #10 with 1" deflection. Photo also shows rust at the intersection of the diagonal members.

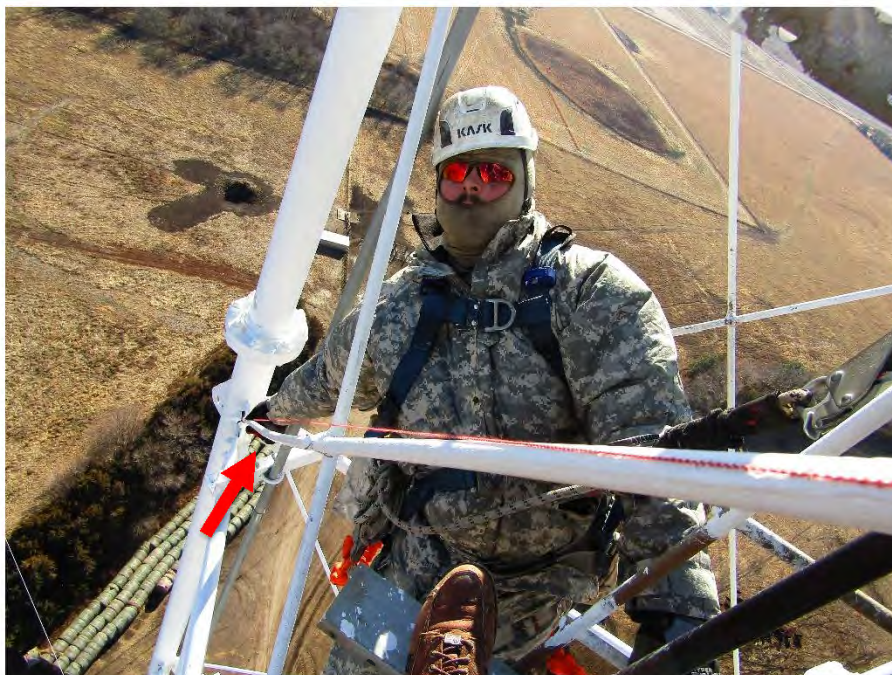
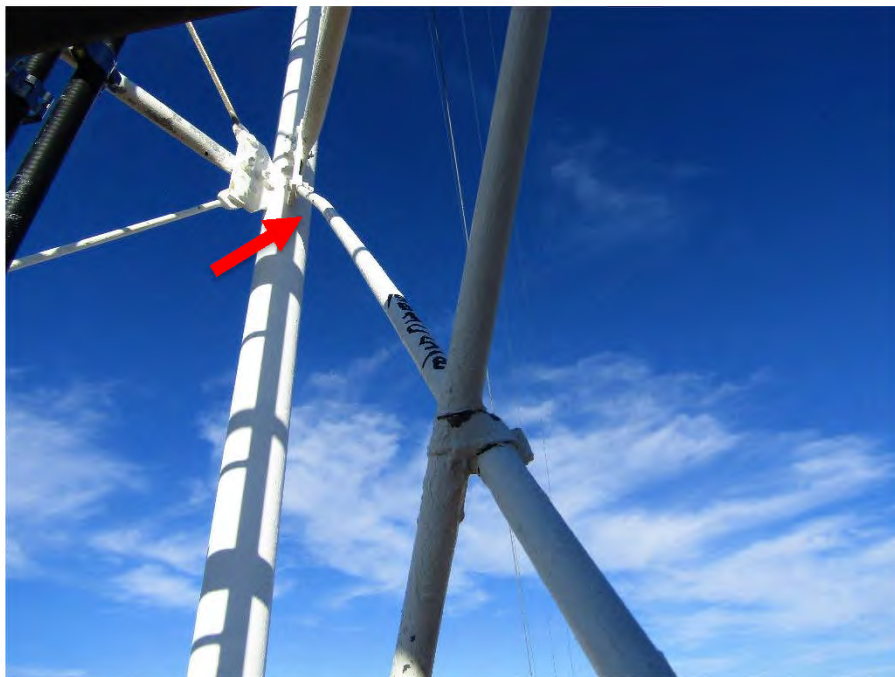
One diagonal member in Section #15, Bay #1, on Face C is bent at the upper and lower ends of the member. We recommend that this member be replaced. ****Priority**

Bend at the lower end of diagonal member in Section #15.

Bend at the upper end of diagonal member in Section #15.

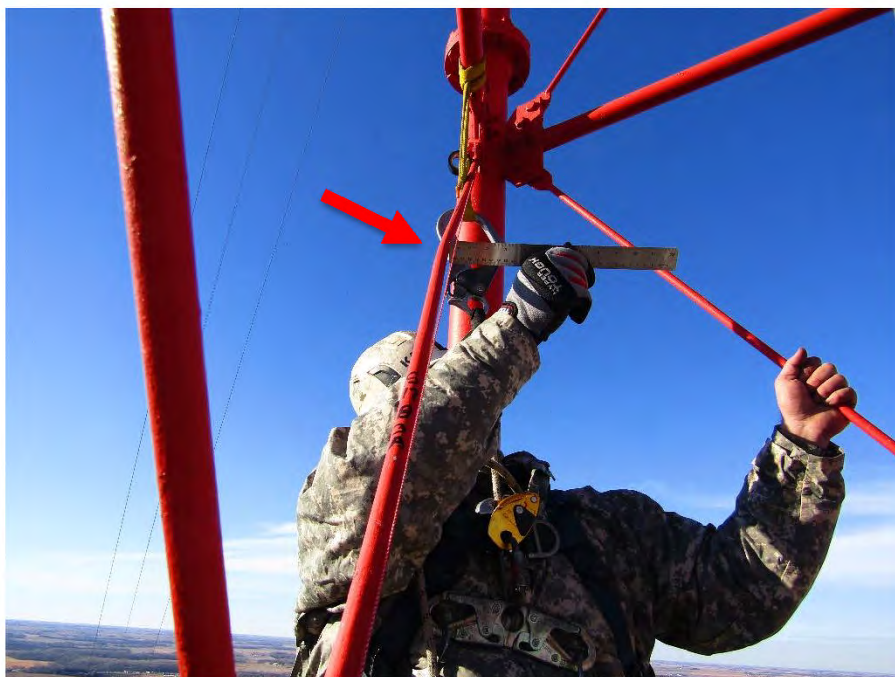
25

One diagonal member in Section #17, Bay #3, on Face A is bent. We recommend that this member be replaced. ****Priority**

Bent diagonal member in Section #17.

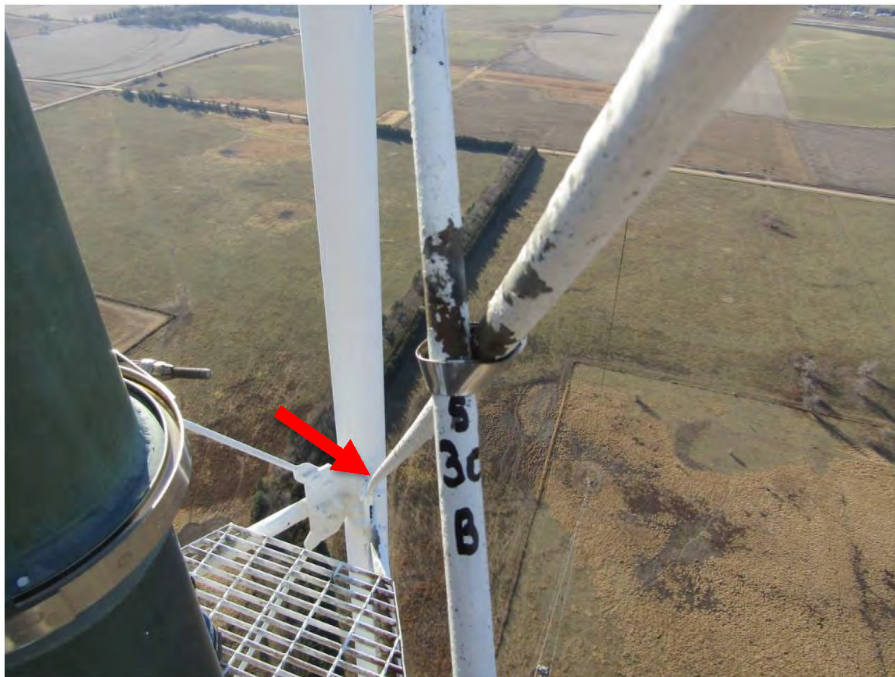
26

One diagonal member in Section #30, Bay #3, on Face B is bent. We recommend that this member be replaced. ****Priority**

Bent diagonal member in Section #30. Photo also shows loose banding and surface rust at the intersection of the diagonal members.

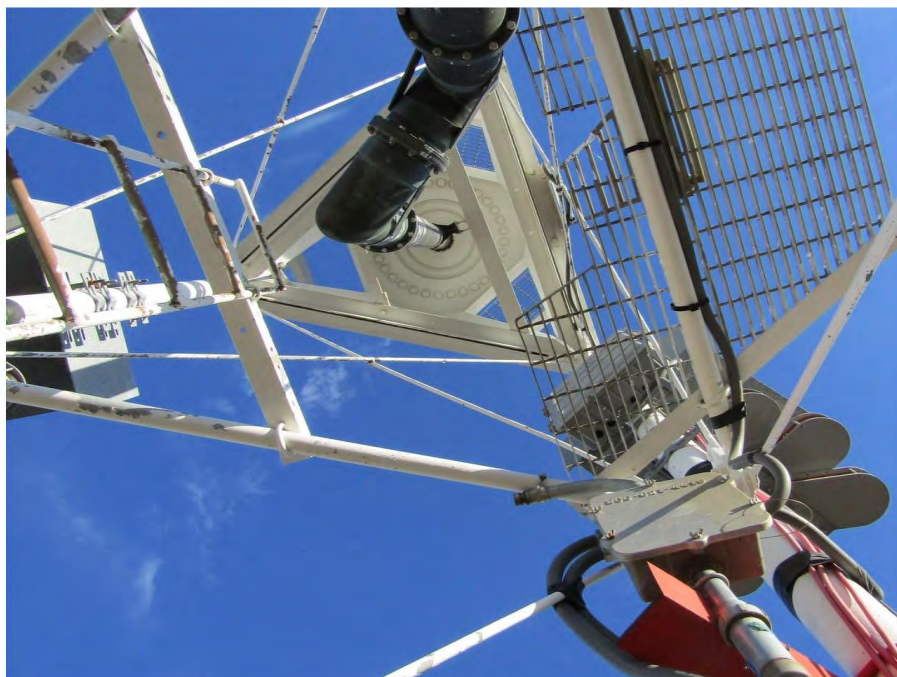
27

Surface rust on the ladder.

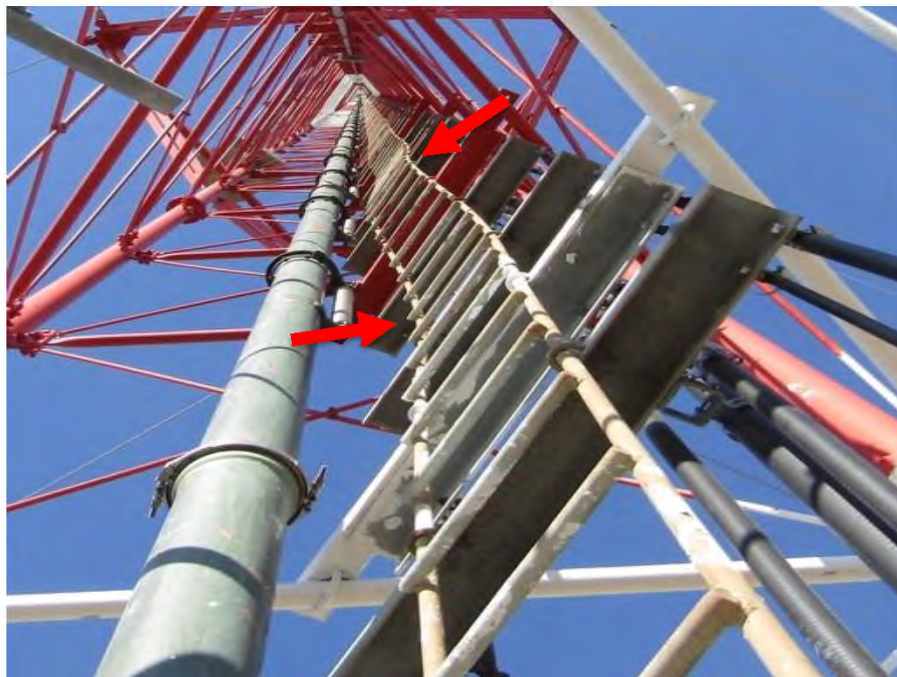
28

The ladder is significantly bowed at two locations just below the second guy level. This represents a possible climbing hazard and is a safety concern. We recommend that the bowed ladder sections be replaced, and that all U-bolts securing the ladder be checked and tightened throughout the tower, as needed. ****Priority**

C-channel mounting brackets secured to the ladder below guy level #2. Photo also shows two significant bows in the ladder.

3. Replace 2 customer supplied ladder sections and hardware below guy level 2.
4. Punch new holes for conduit U bolts on back side of ladder as needed.
5. Install 2 runs of customer supplied 1" conduit and hardware on back side of ladder. (qty 155 pieces of 1"x10' long rigid conduit.)

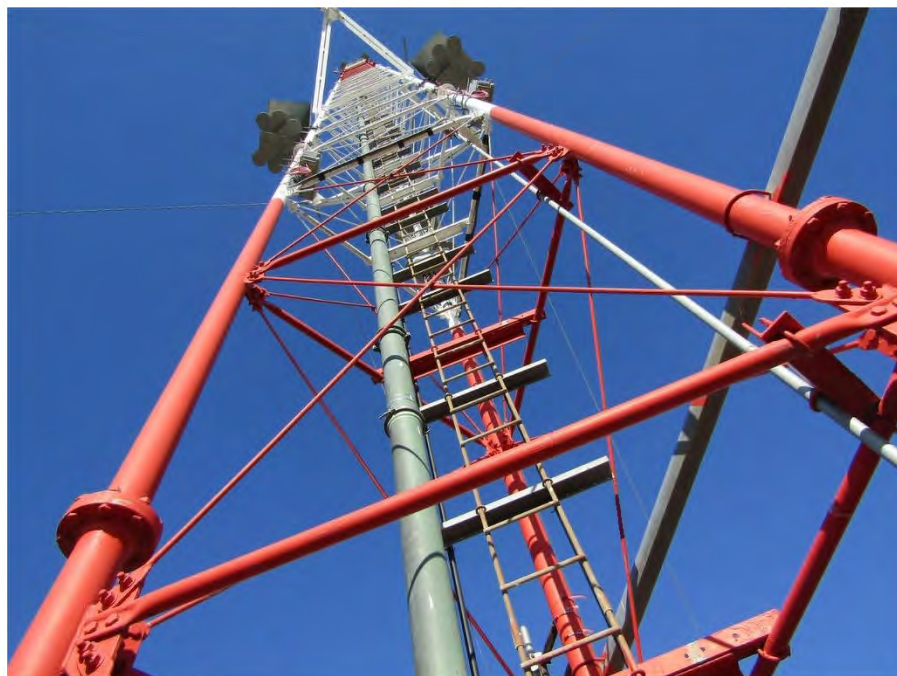
29

C-channel mounting brackets secured to the ladder below guy level #4.

6. Move coax from brackets u-bolted to ladder to the new conduit with existing butterflies and hardware or up to 100 new ones (customer supplied) then remove brackets from ladder.

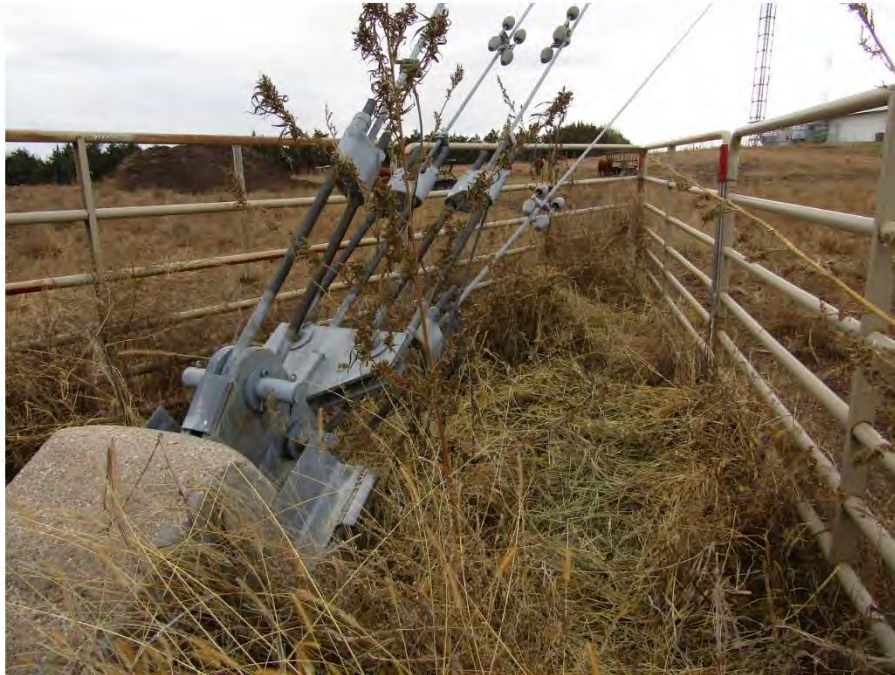
30

Inner anchor A with brush growing on the guy wires.

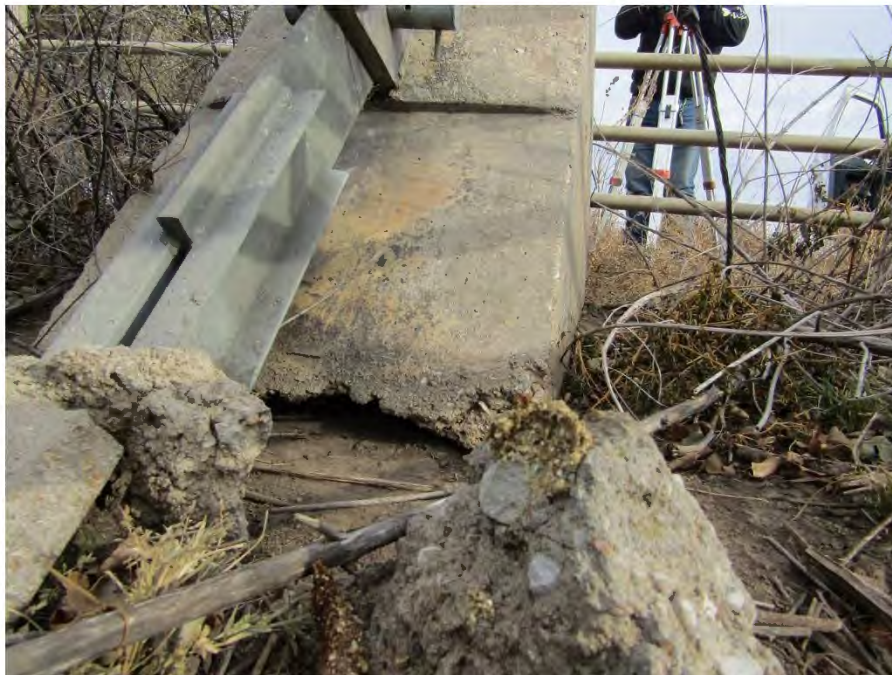
32

There are broken chunks of concrete at the outer anchor A foundation, and slight cracks in the concrete at the inner anchor B and outer anchor C foundations. We recommend that the outer anchor A foundation be repaired, and the cracks in the concrete at the inner anchor B and outer anchor C foundations be patched and sealed.

Broken concrete at the outer anchor A.

9. Patch and seal concrete anchors with grout as needed.
10. Complete Plumb and Tension on tower.
11. Relocate and properly secure hoisting grip in Sec. 20 on the 1/2" coax to strut location.

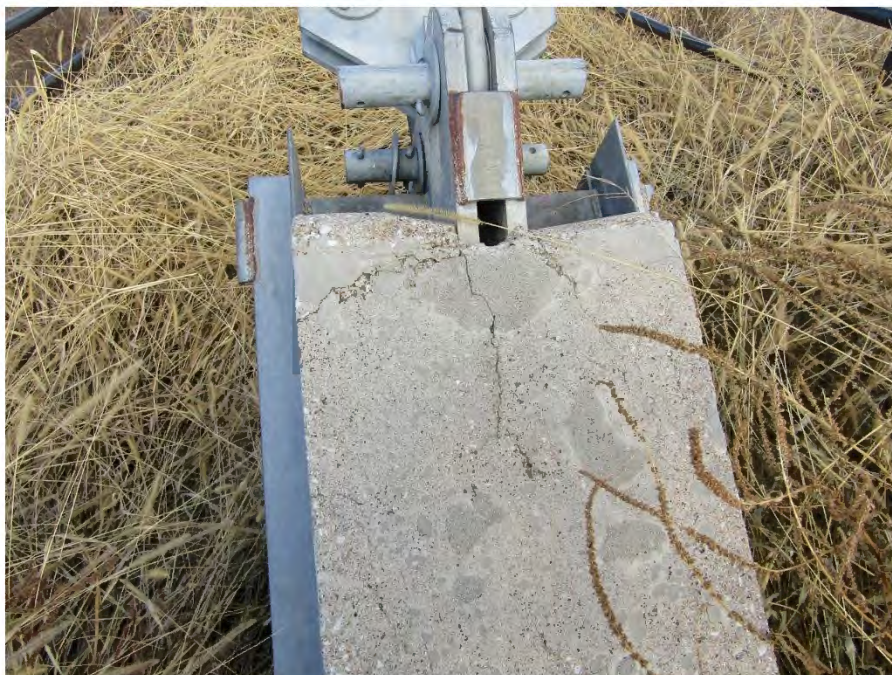
33

Small cracks in the concrete at the inner anchor B.

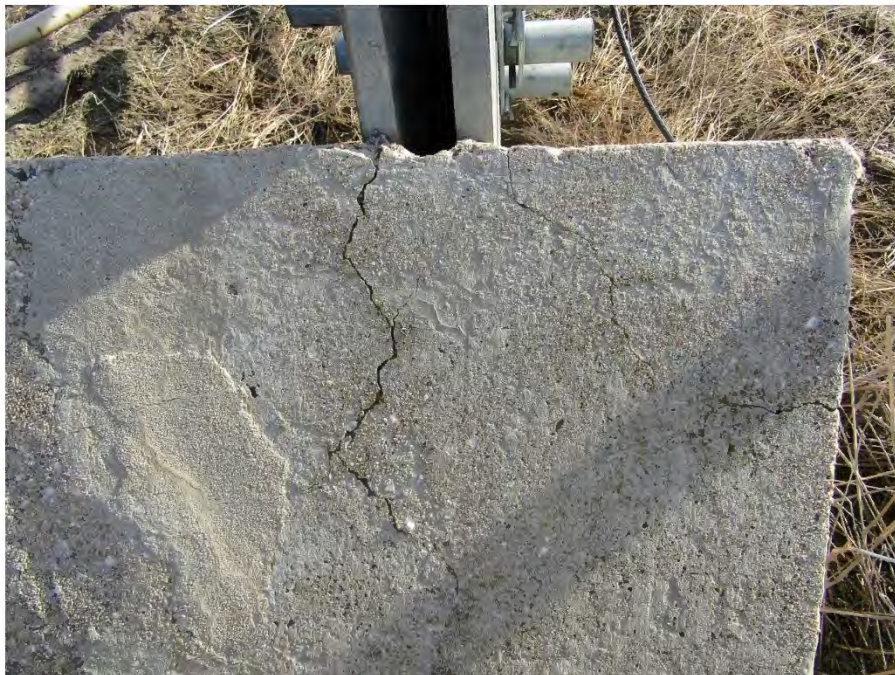
34

Small cracks in the concrete at the outer anchor C.

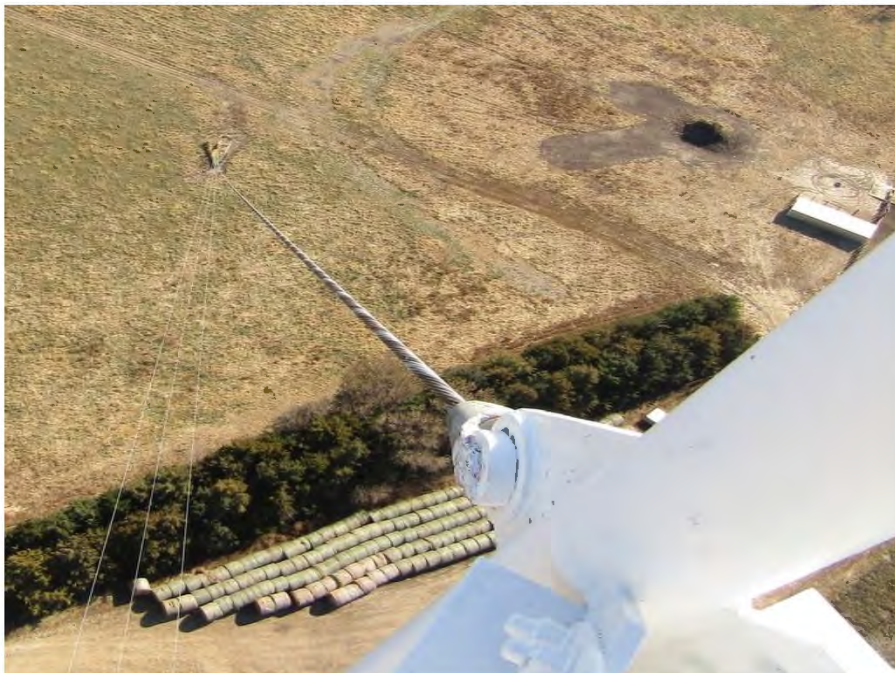
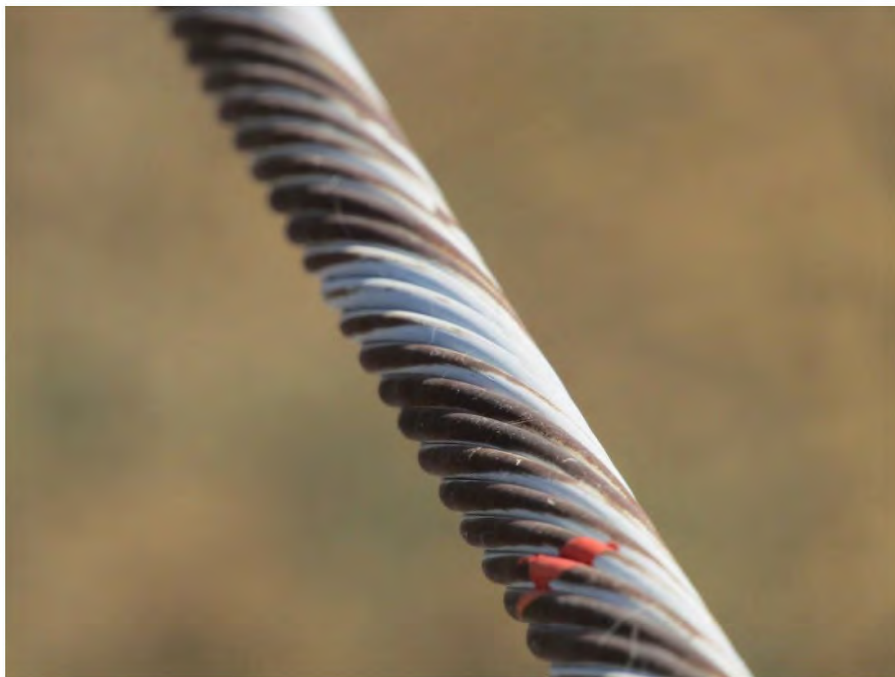
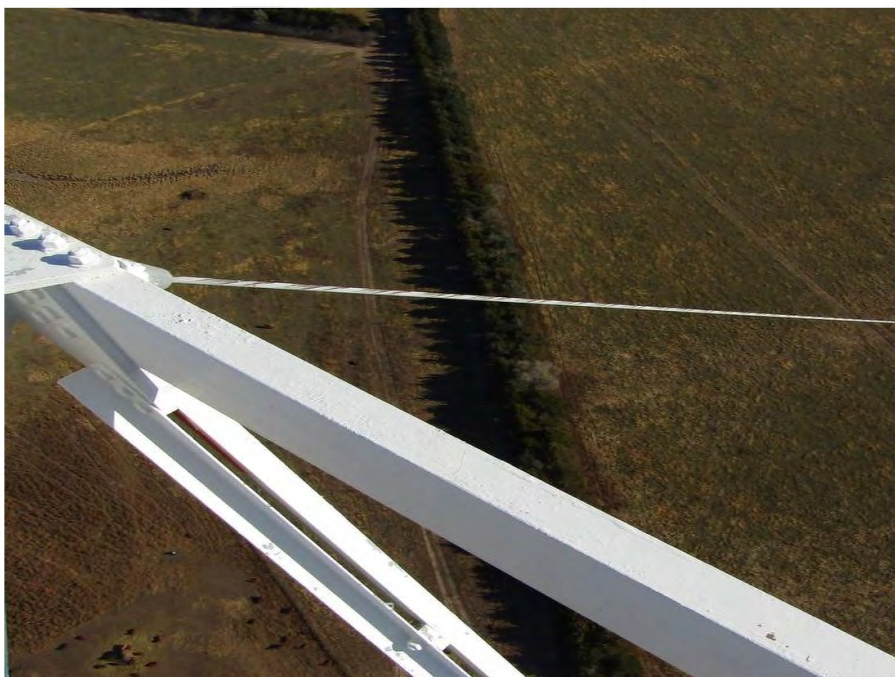
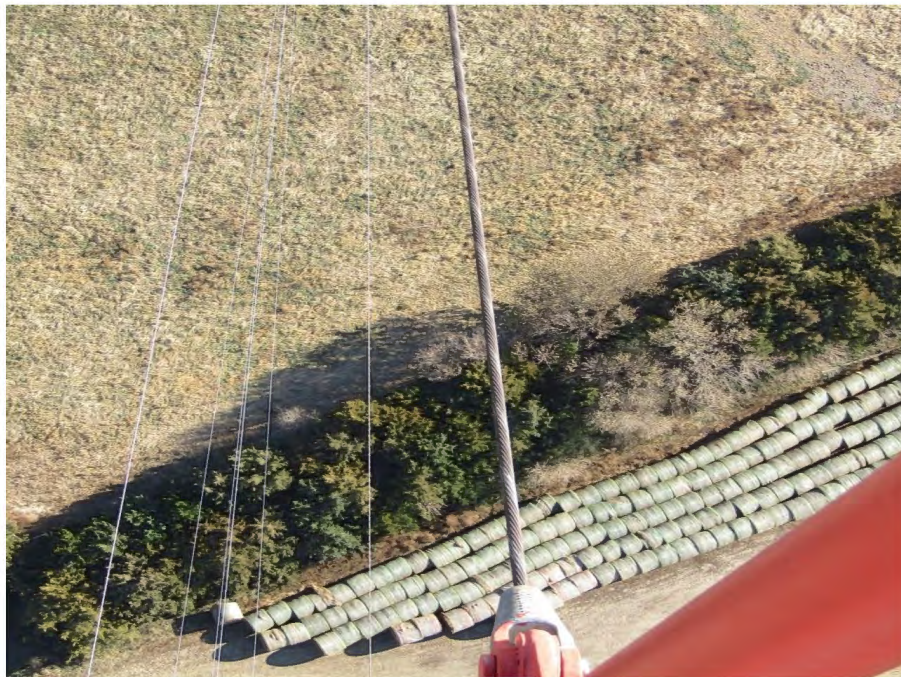
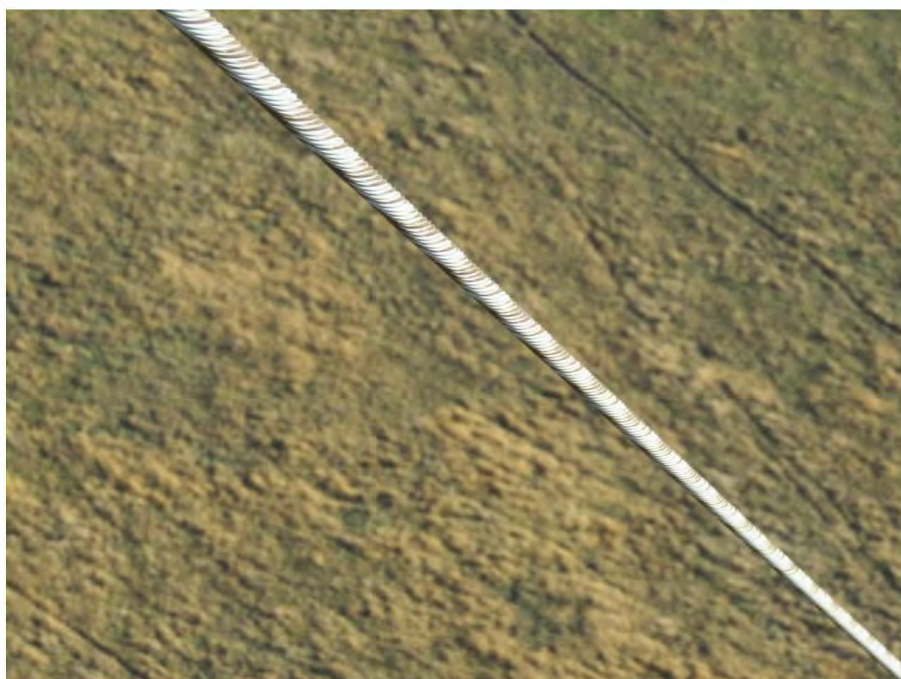
There are areas of surface rust on the guy wires, mostly at the upper elevations of each wire. We recommend treating the guy wires with an anodic self-priming paint or paraffin wax to prevent the progression of the rusting.

Typical areas of surface rust on at the upper end of a level #3 guy wire.

Typical areas of surface rust on a level #3 guy wire.

Typical areas of surface rust on a level #4 guy wire.

Typical areas of surface rust on a level #5 guy wire.

Typical areas of surface rust on a level #6 guy wire.

2.	Section V	Page 27	Are you requesting contractor to re-coat the guy wires?	Re-coating the guy wires are required. RFP Section V.D., third paragraph is hereby modified to include the following: While on site for diagonal replacements, begin treatment of 16 wires on workface, complete treatment of remaining 8 wires on back leg. Bidder is to supply a grease coating for the guy wires. The type of grease selected must be of a type designed for this application.

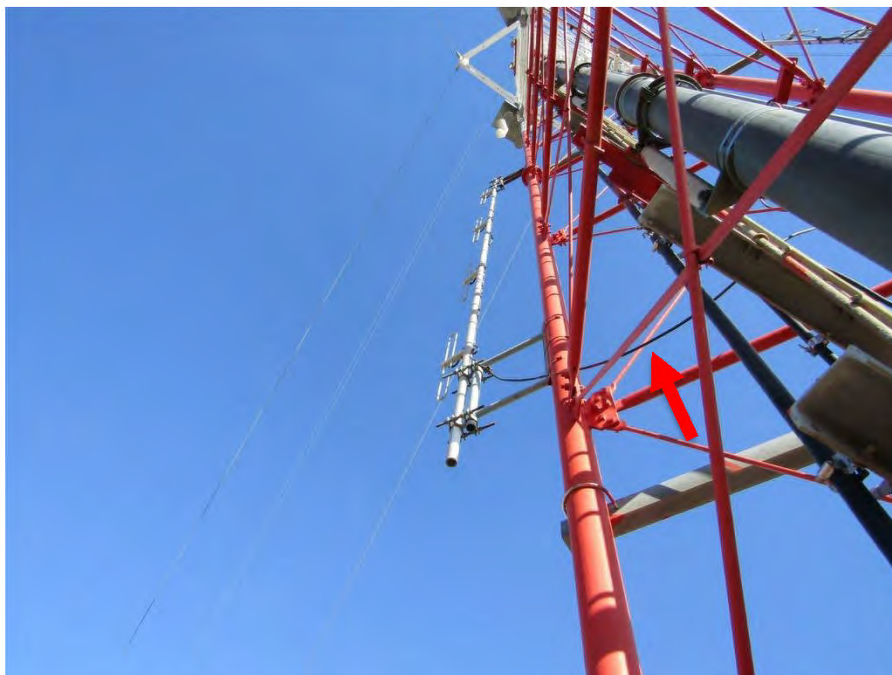
50

Several cables and flexible lines to ancillary antennas were found to be unsecured at several locations. The lines were temporarily secured with electrical tape and nylon zip ties during the inspection. We recommend that the lines be secured with proper stainless steel hardware, and that the broken hangers that have slid down the line in section #15 be removed.

Flexible line to the dipole antenna in section #20 was unsecured. The line was temporarily secured with electrical tape during the inspection.

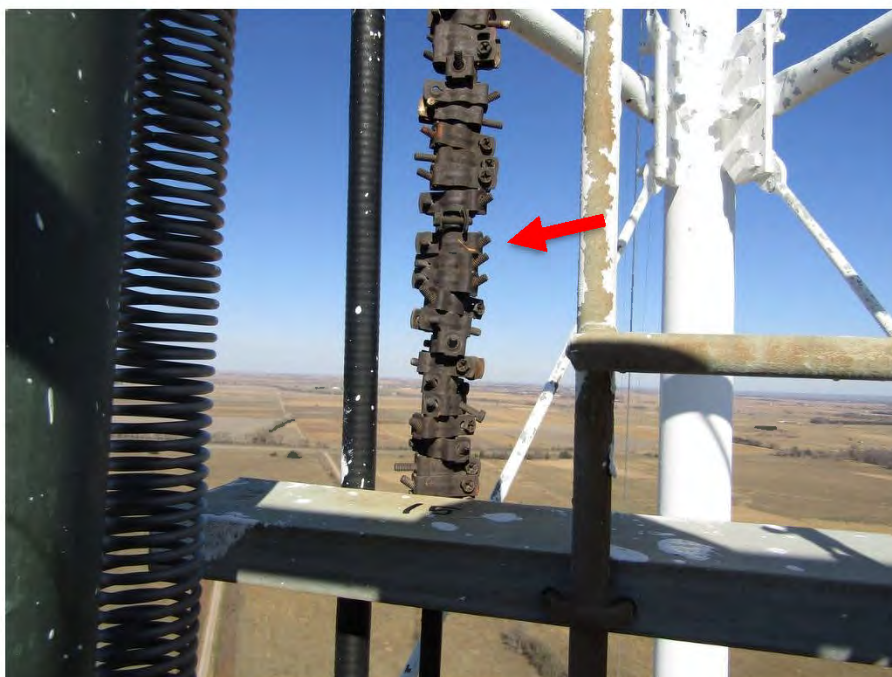
51

Broken hangers that slid down a flexible line in section #15. The crew temporarily secured the line with zip ties.

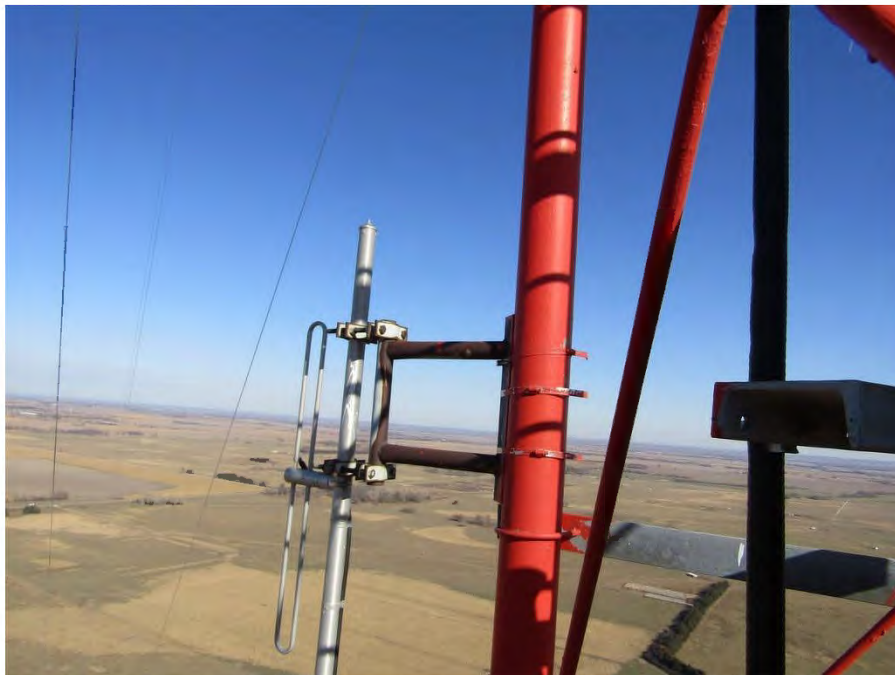
52

There is light to moderate surface rust on the mount for the dipole antenna in section #20. We recommend that the rusting areas be treated and coated with a high zinc content primer.

Surface rust on the mount for the dipole antenna in section #20.

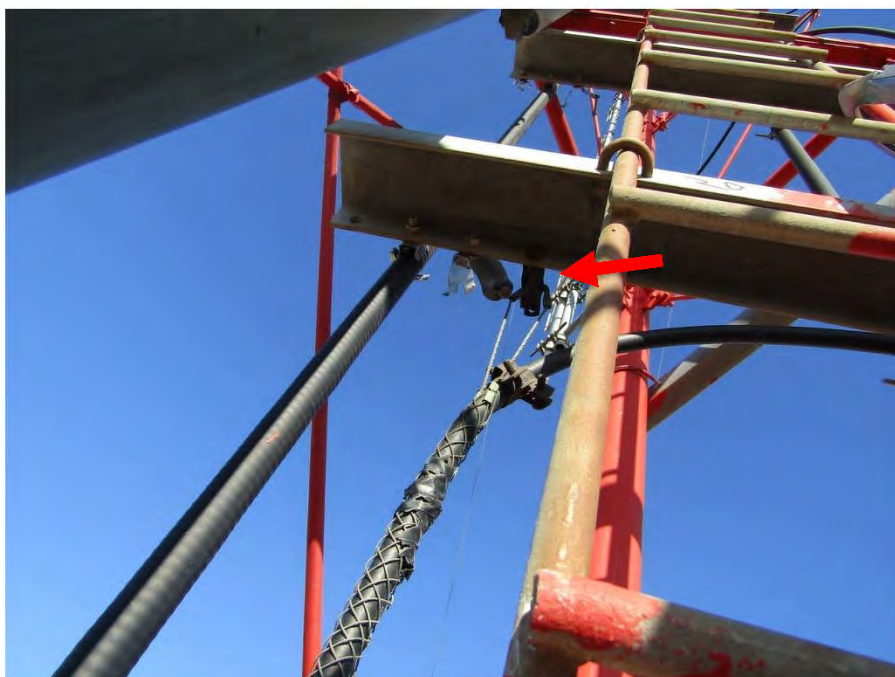
53

The hoisting grip for the flexible line feeding the dipole antenna in section #20 is secured with a butterfly clamp. We recommend that the grip be supported with stronger hardware.

Hoisting grip for the flexible line feeding the dipole antenna in section #20 secured with a butterfly clamp.

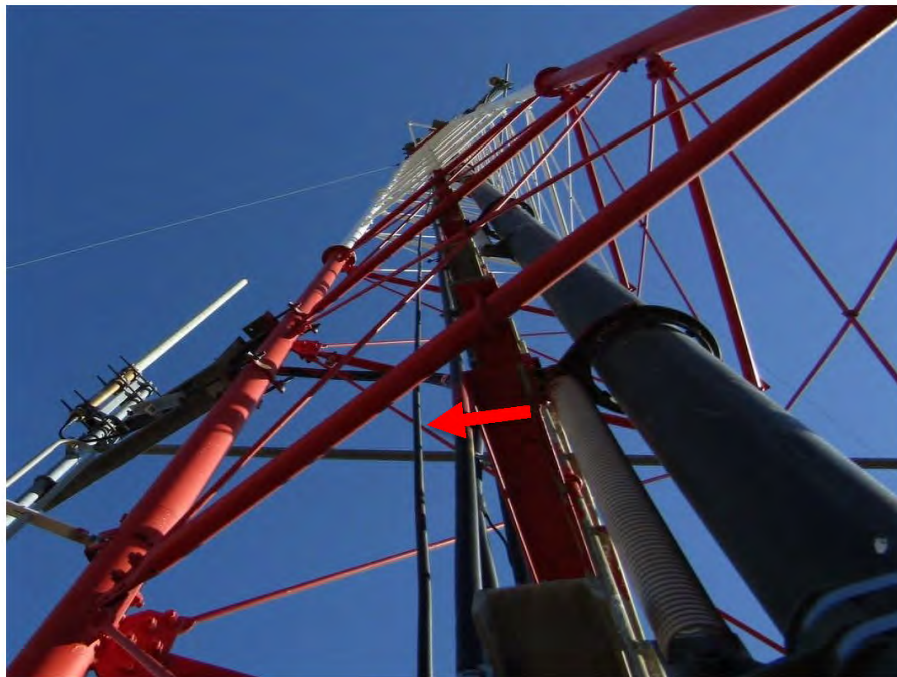
54

Unsecured flexible line noted in photo #50, before being temporarily secured by the inspection crew.
