KUON
Ithaca, NE
2023

INSPECTION REPORT

DATE: 11/11/2023

Type: Guyed

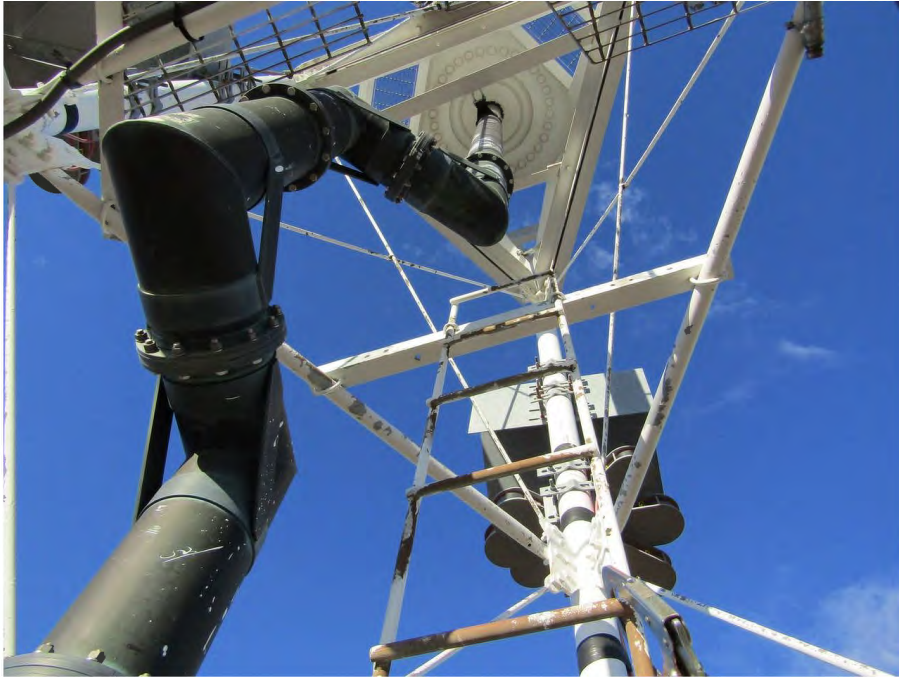
4

There are areas of surface rust on the ladder where the galvanizing appears to be worn off. We recommend that the rusting areas be treated.

Transmission line elbow complex below the antenna input. Photo also shows some surface rust on the ladder.

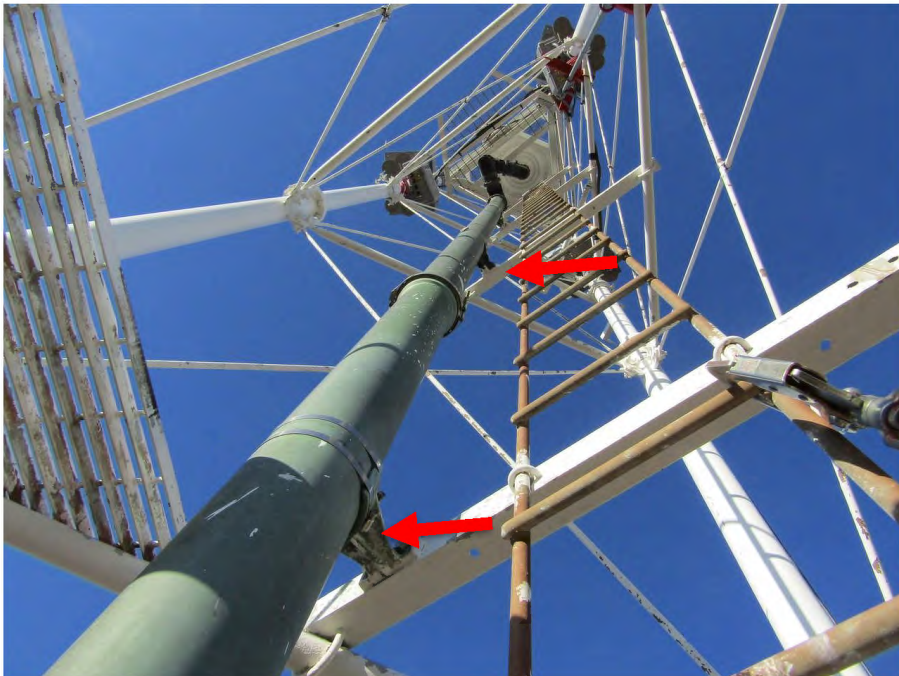
5

Fixed hangers below the top elbow complex. Photo also shows some surface rust on the ladder.

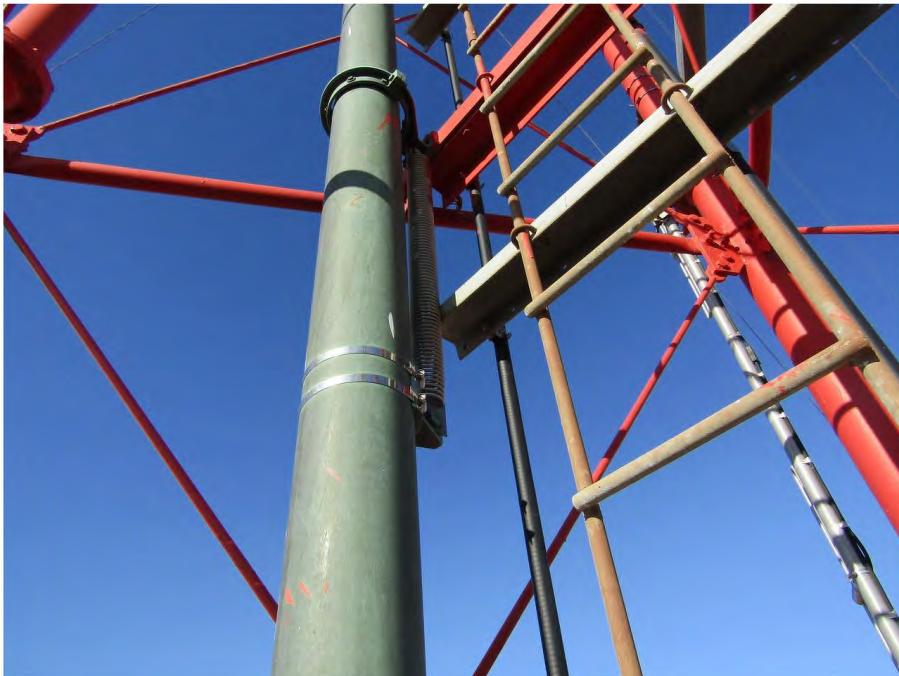
7

Typical spring hanger. Photo also shows surface rust on the ladder.

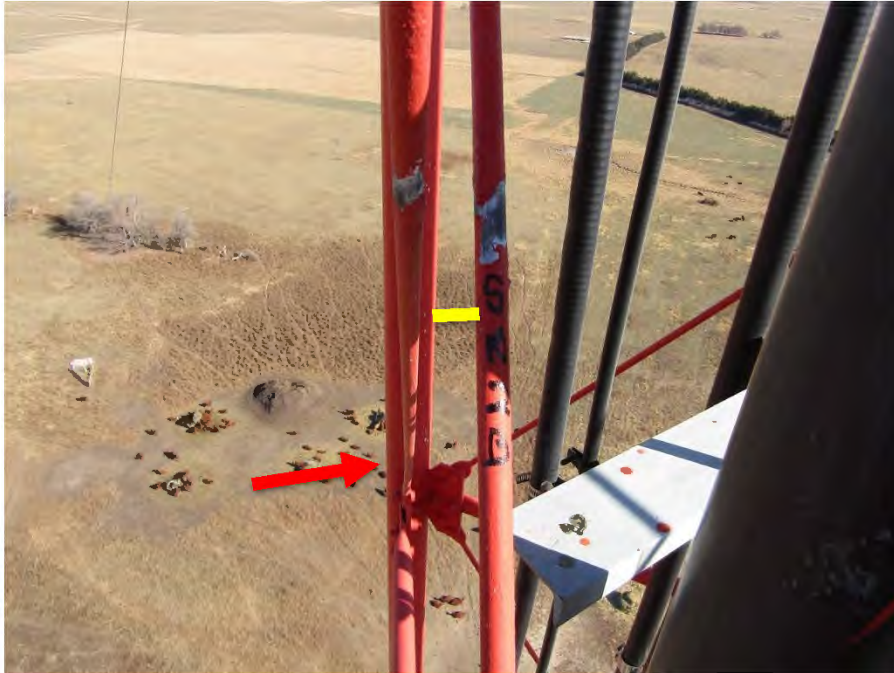
22

The banding that secures diagonal members at their intersections is loose or missing in multiple sections throughout the tower. The banding is stretching over time. These conditions can cause wear and loss of steel where the diagonal members rub and hit each other at the intersections. We recommend that the banding be removed from all diagonals throughout the tower and replaced with U-bolts and backing plates.

There is surface rust at the intersection of some diagonal members that have loose or missing banding. We recommend that all rusting areas be treated and coated with a high zinc content primer when the bandings are replaced with U-bolts and backing plates.

One diagonal member in Section #10, Bay #2, on Face B is bent. We recommend that this member be replaced. ****Priority**

Bent diagonal member in Section #10 with 1" deflection. Photo also shows rust at the intersection of the diagonal members.

Note: All of the diagonals are mounted to the outside of the gusset plates, and this is causing them to bow at their intersections. Some look worse than others for this reason. Upon replacement of the damaged diagonal members, installing the new rods at the inside of the gusset plates would help reduce the bowing around each other.

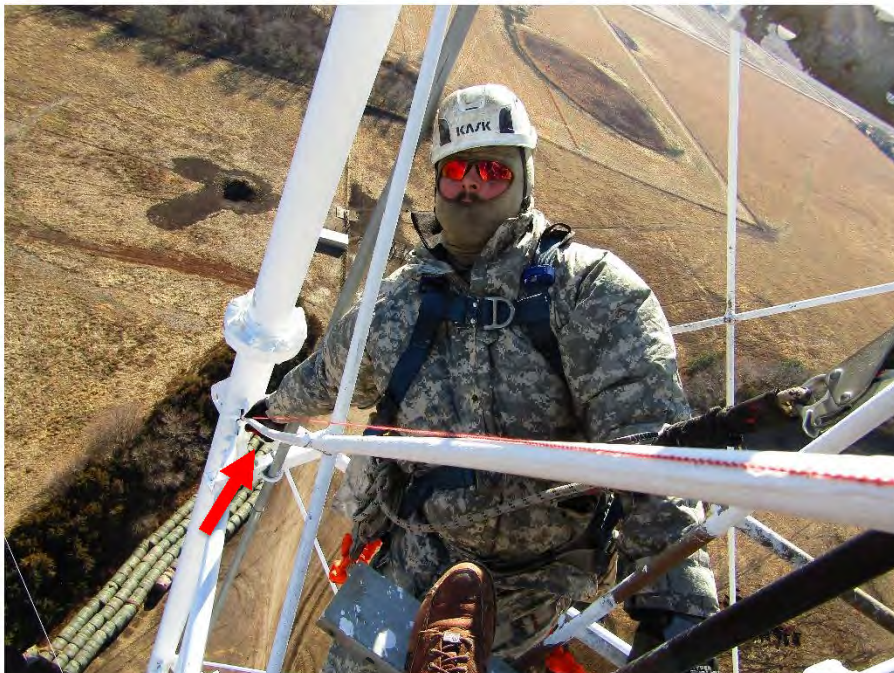
23

One diagonal member in Section #15, Bay #1, on Face C is bent at the upper and lower ends of the member. We recommend that this member be replaced. ****Priority**

Bend at the lower end of diagonal member in Section #15.

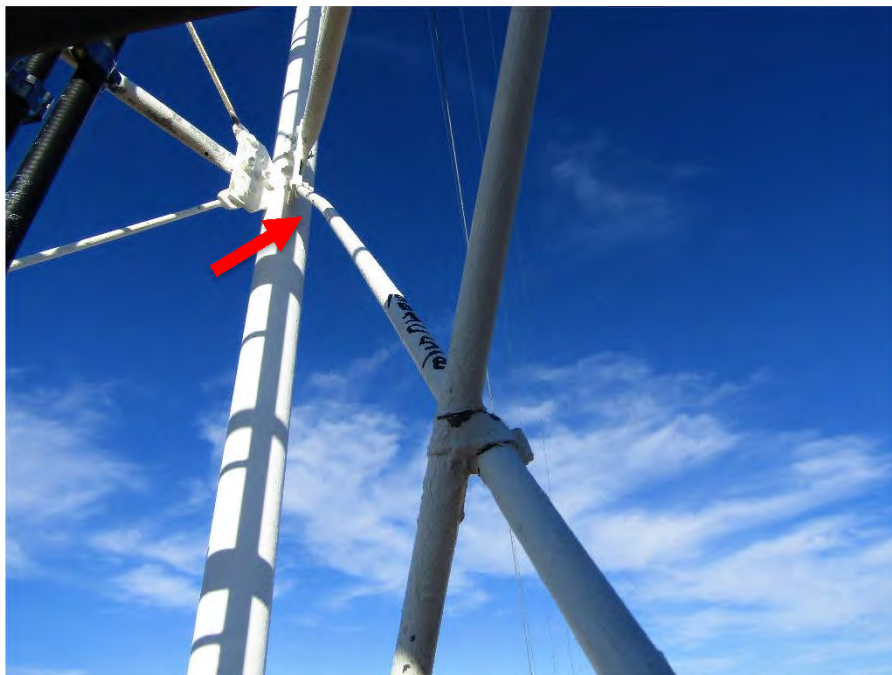
24

Bend at the upper end of diagonal member in Section #15.

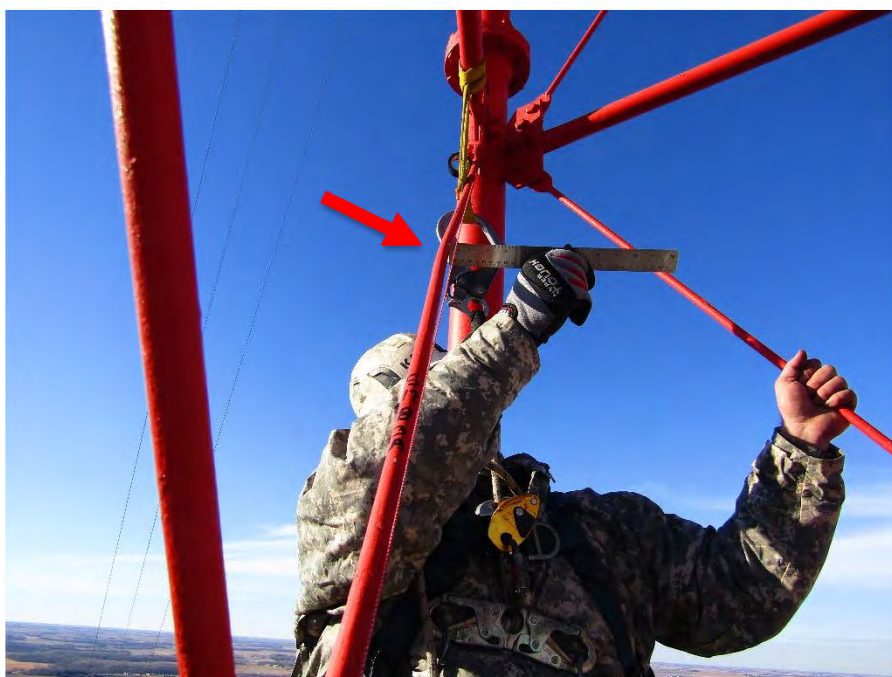
25

One diagonal member in Section #17, Bay #3, on Face A is bent. We recommend that this member be replaced. ****Priority**

Bent diagonal member in Section #17.

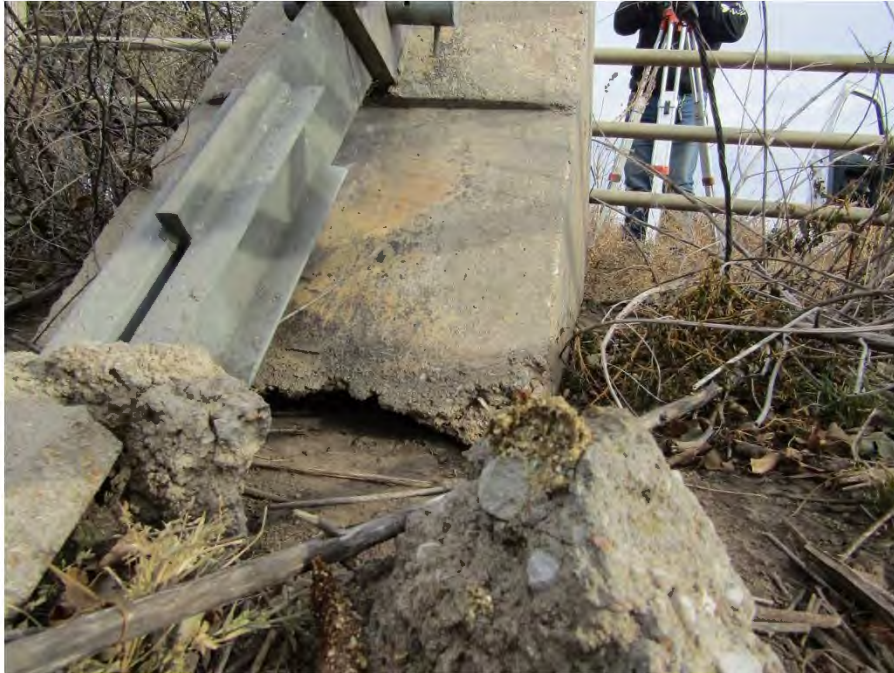
32

There are broken chunks of concrete at the outer anchor A foundation, and slight cracks in the concrete at the inner anchor B and outer anchor C foundations. We recommend that the outer anchor A foundation be repaired, and the cracks in the concrete at the inner anchor B and outer anchor C foundations be patched and sealed.

Broken concrete at the outer anchor A.

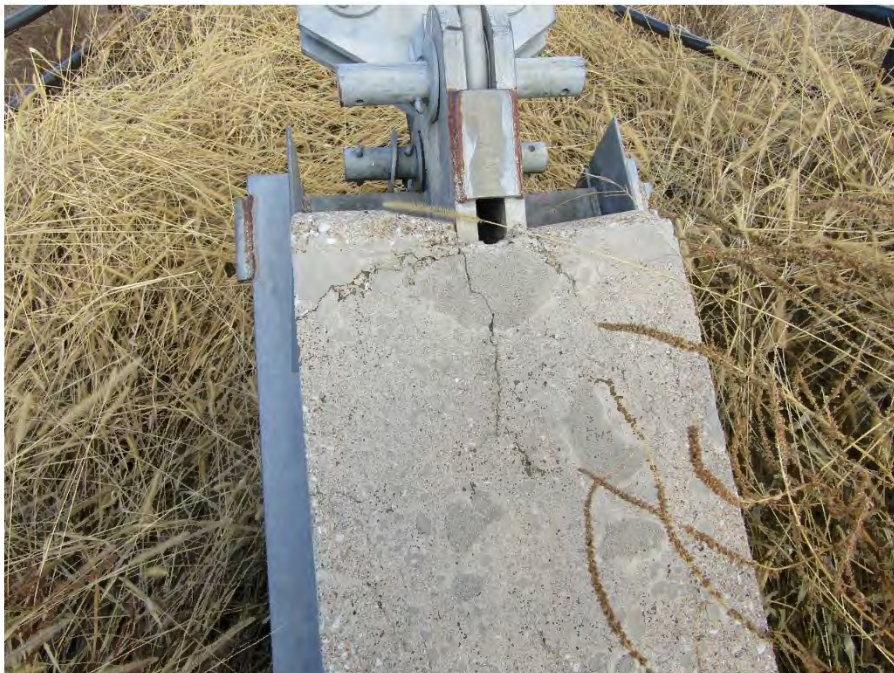
33

Small cracks in the concrete at the inner anchor B.

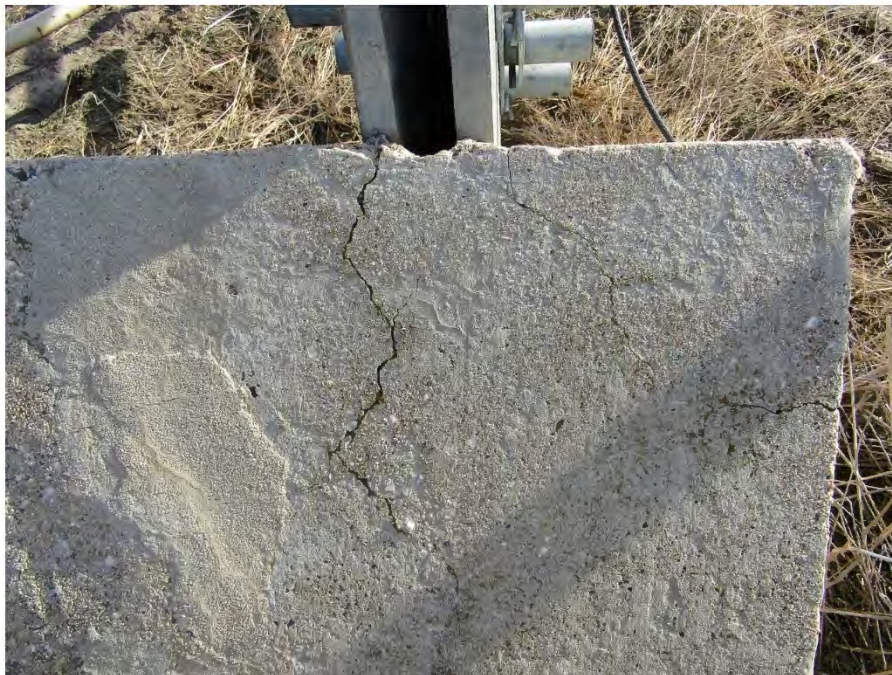
34

Small cracks in the concrete at the outer anchor C.

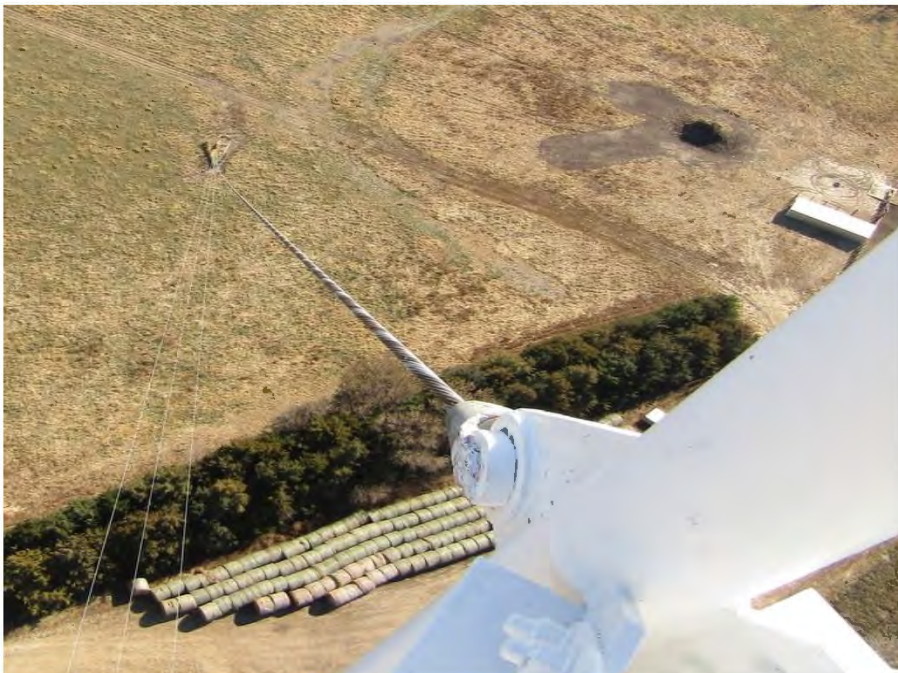
39

There are areas of surface rust on the guy wires, mostly at the upper elevations of each wire. We recommend treating the guy wires with an anodic self-priming paint or paraffin wax to prevent the progression of the rusting.

Typical areas of surface rust on at the upper end of a level #3 guy wire.

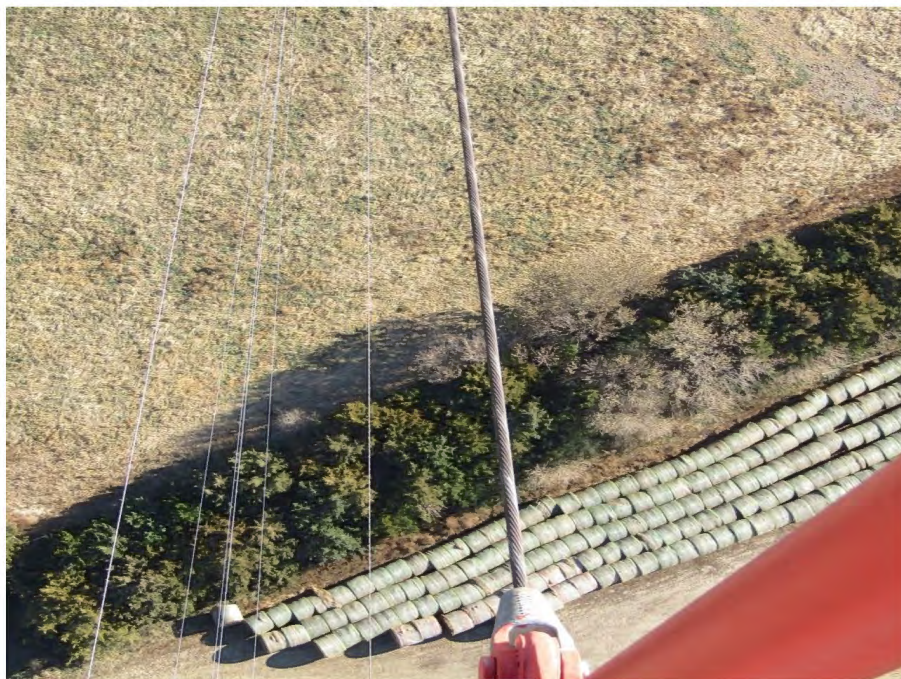
42

Typical areas of surface rust on a level #5 guy wire.

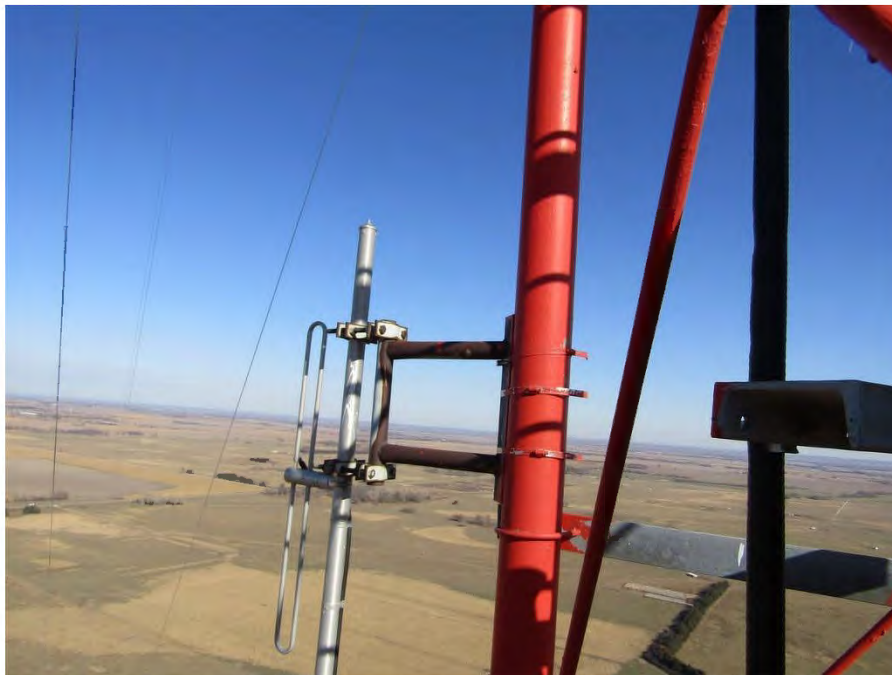
52

There is light to moderate surface rust on the mount for the dipole antenna in section #20. We recommend that the rusting areas be treated and coated with a high zinc content primer.

Surface rust on the mount for the dipole antenna in section #20.

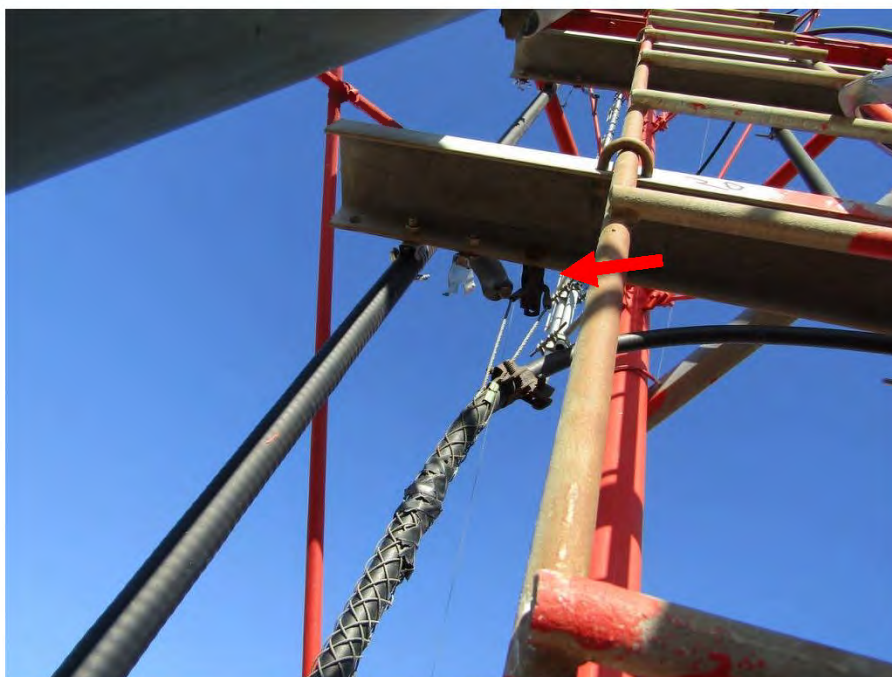
53

The hoisting grip for the flexible line feeding the dipole antenna in section #20 is secured with a butterfly clamp. We recommend that the grip be supported with stronger hardware.

Hoisting grip for the flexible line feeding the dipole antenna in section #20 secured with a butterfly clamp.
